DEPARTMENT OF TRANS FEDERAL RAILROAD ADM							
ALLEGED FALSE PROCEED SIGNAL REPORT		DATE	January 24, 1997				
MAIL TO		REPOR'	REPORTING CARRIER (railroad & region or division)				
Mr. Tom MoFarlin		Burlingt	Burlington Northern Santa Fe Railway/Burlington Lines/Nebraska/St Joesph Sub				
Mr. Tom McFarlin Signal & Train Control Specialist Federal Railroad Administration 1100 Main Street, Suite 1130 Kansas City, MO 64105		ER REPOR	FING OFFICER (sig				
	, ·		72				
A failure should not be counted more than one time in items 1, 2, 3, and 4; the failure should be classified under the basic system or appliance of which it forms an essential part. E.g.: assume grounds cause a block signal to indicate a false proceed causing corresponding indicates a false proceed causing this point, such failure should be included in Item 1. Block System A false proceed failure is a failure of a system device or appliance to indicate or function as intended which results in less restriction than intended.		AAS CAB hould ACS APB ATC ATS CL	PB -Absolute permissive block CC -Automatic train control CS -Automatic train stop CL -Color light		the report EM EP FP MP M P PL	Electromechanical -Electropneumatic -F

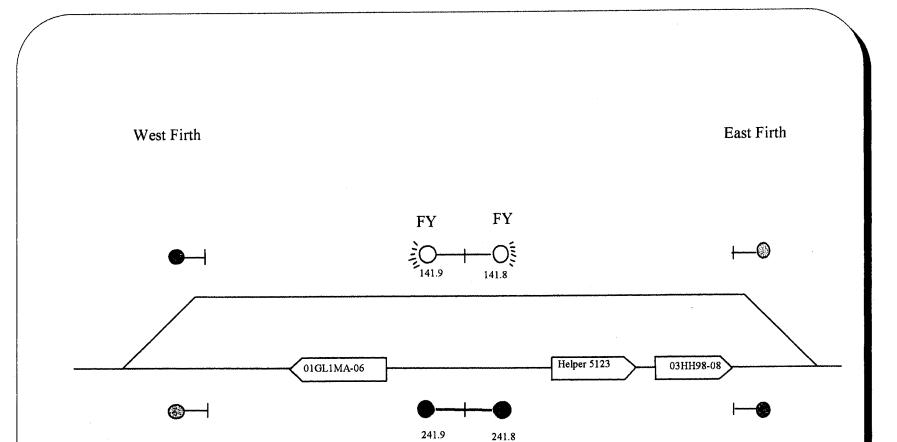
Signal 141.9 displayed a FY with this scenario, per design, however condition did not exist with train occuping main one between E. Firth and signal 141.8 or if West Firth Lined eastward on to main track one.
